TS-PIC-92135
December 1992

Site Analysis
North Bronson Industrial Area
Bronson, Michigan

by
David B. Riccio, Imagery Analyst
The Bionetics Corporation
Warrenton, Virginia 22186

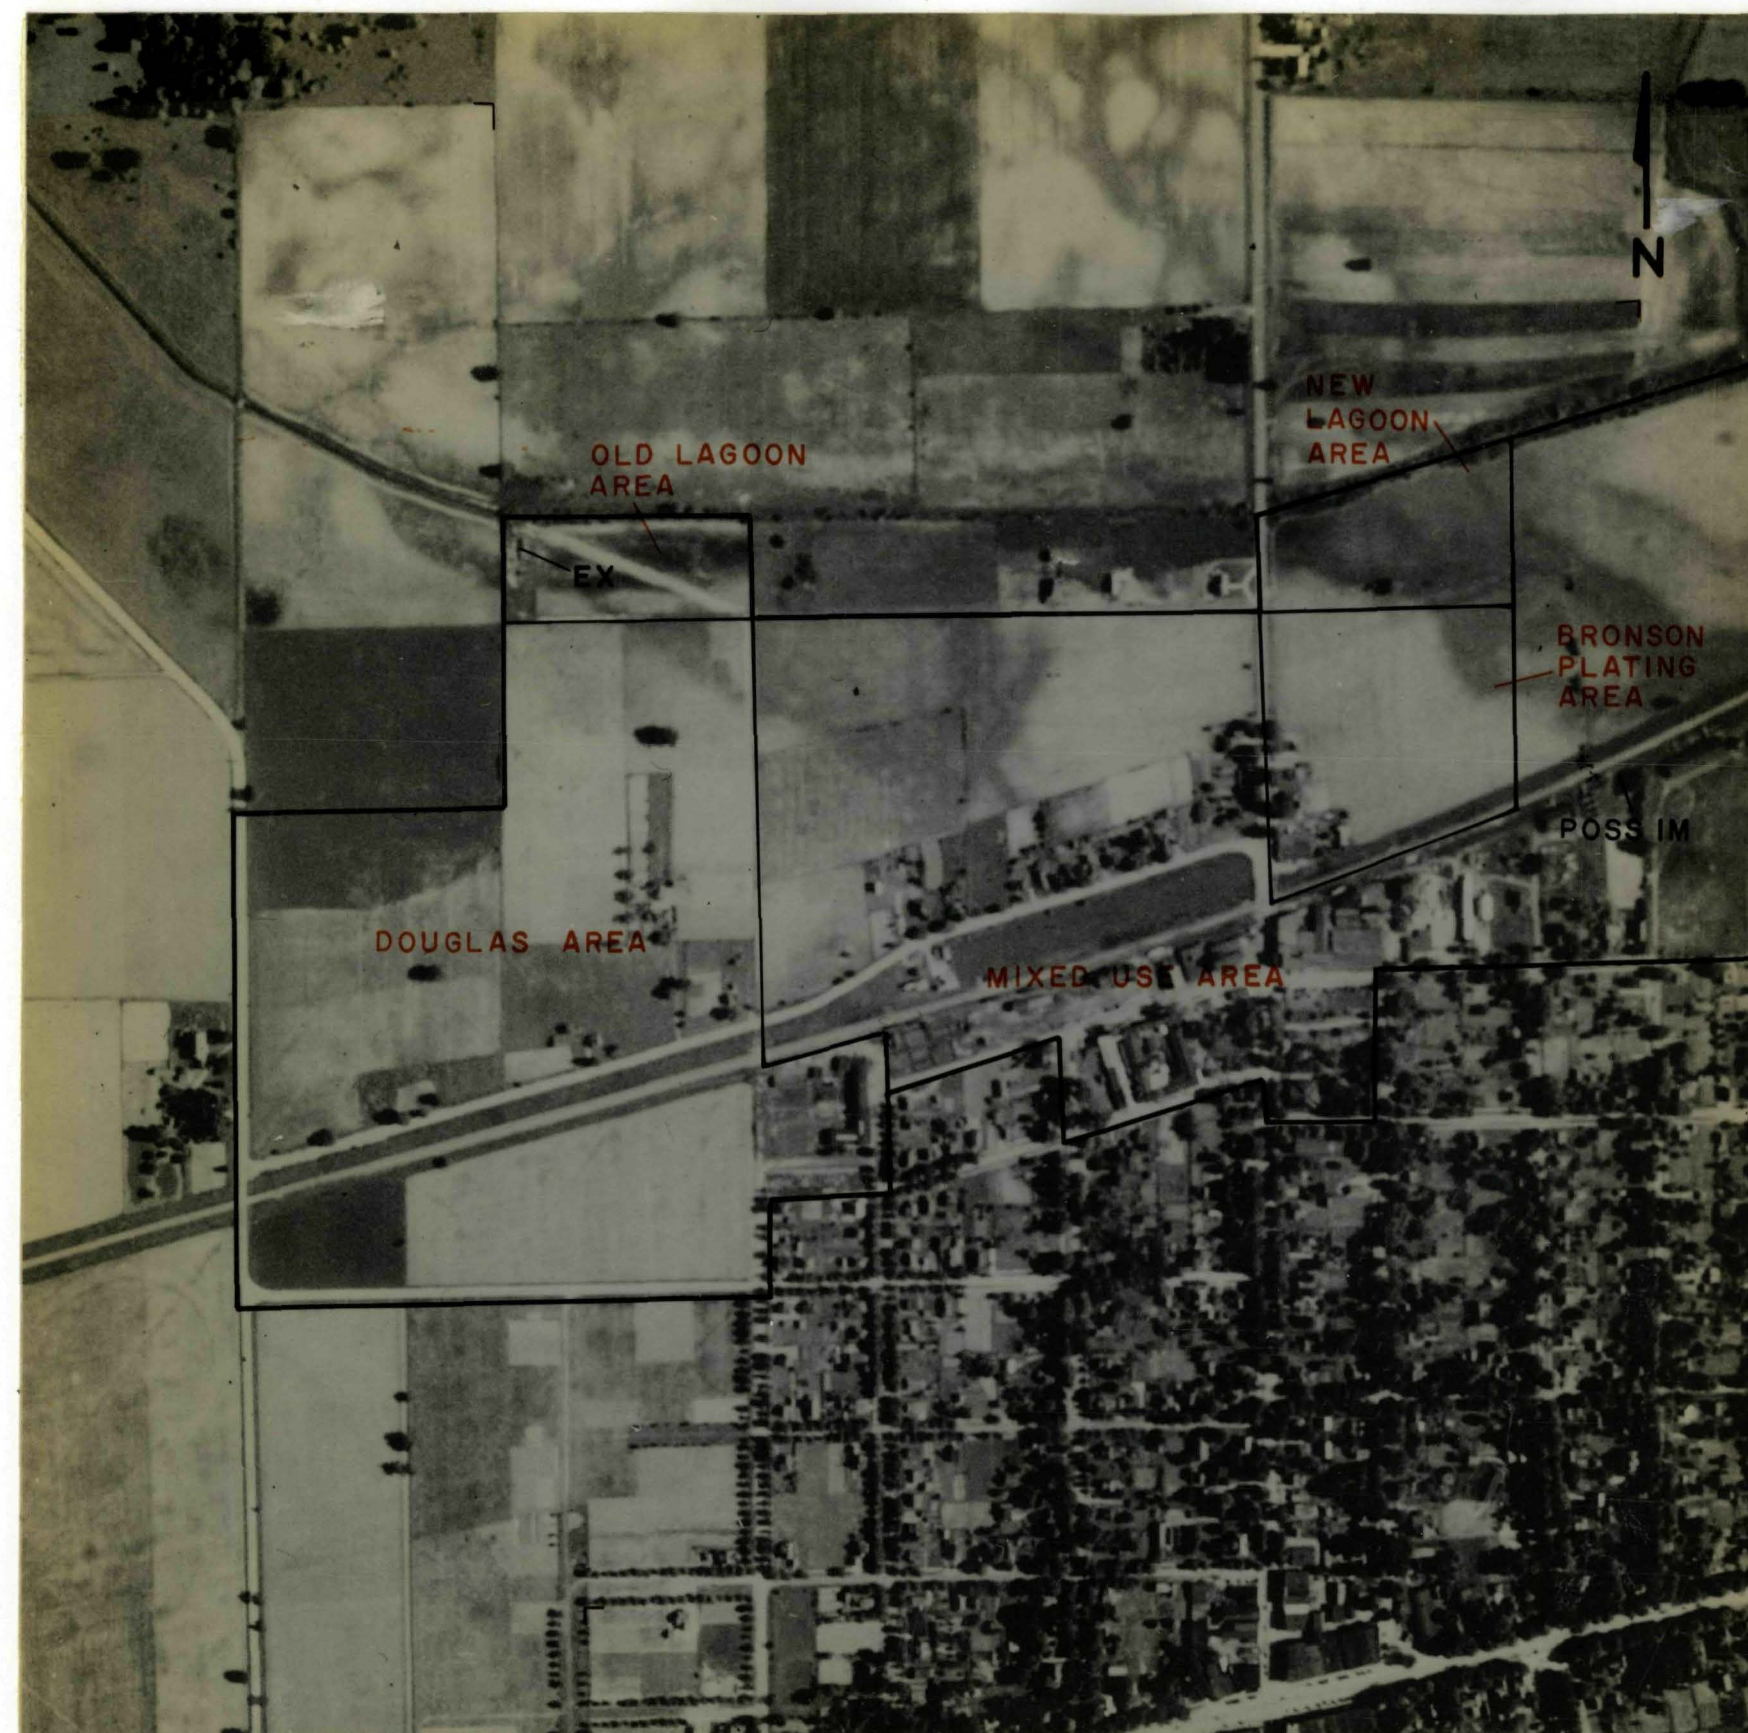
FIGURE 3
N. BRONSON IND.
AREA

This photography illustrates pre-site conditions, although some buildings are present in the Mixed Use Area.

The lagoons reportedly constructed in the late 1930's are not seen this year; however, an excavation (EX) noted near the west edge of the Old Lagoon Area may depict initial lagoon construction. No other evidence of lagoons is observed.

A possible impoundment (IM) borders the railroad (not annotated) in the southeast corner of the Mixed Use Area.

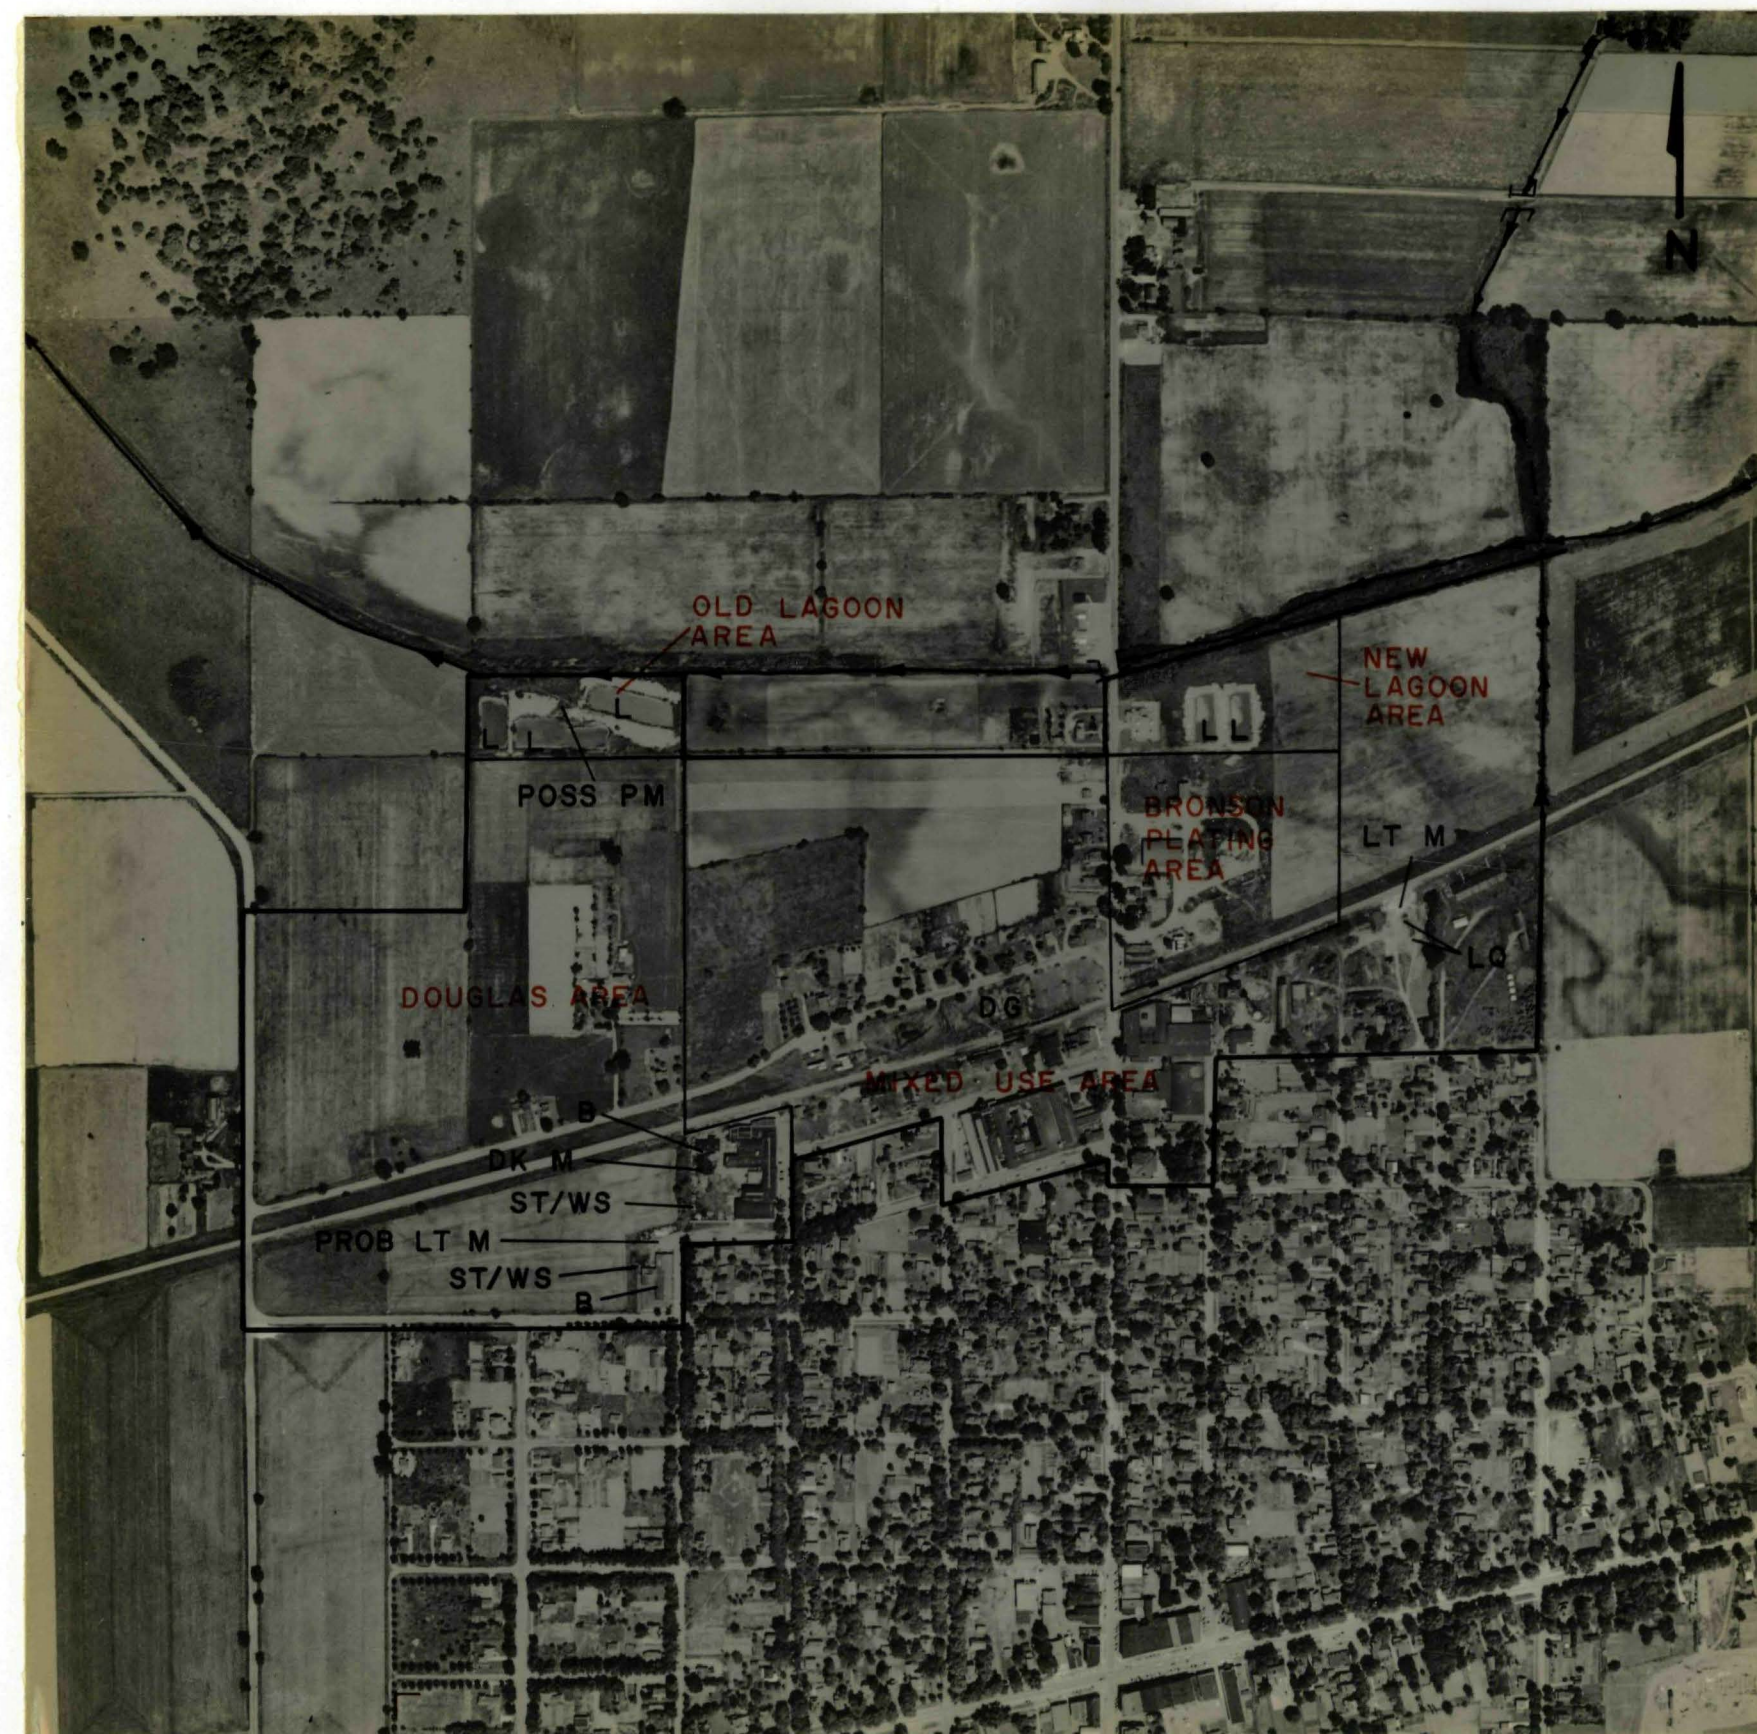
FIGURE 4
N. BRONSON IND.
AREA

Surface drainage from the northern site boundary moves northward into a tributary of Swan Creek; however, no direct drainage pathways are observed. Any overflow from the old and new lagoons would flow into this bordering drainage pathway.

A drainage channel extends from a lagoon in the old lagoon area. This channel may divert liquid into the tributary of Swan Creek. It will be annotated in subsequent years of photography but will be discussed only when a significant change occurs.

The old lagoons (L) were constructed in the late 1930's, and wastes from these lagoons reportedly breached the berm and flowed into a storm drain. No evidence of leakage from lagoons is observed at this time. All the lagoons are bermed.

A light-toned linear object, possibly piping material (PM), extends from the largest lagoons to the drainage channel.

Buildings, dark-toned (DK) material (M), stains (ST) and wet soil (WS) are noted in the southeastern portion of the Douglas Area. Probable light-toned (LT) material is piled north of the southernmost new building.

Light-toned material and areas of liquid (LQ) are seen where a possible impoundment was observed in 1938.

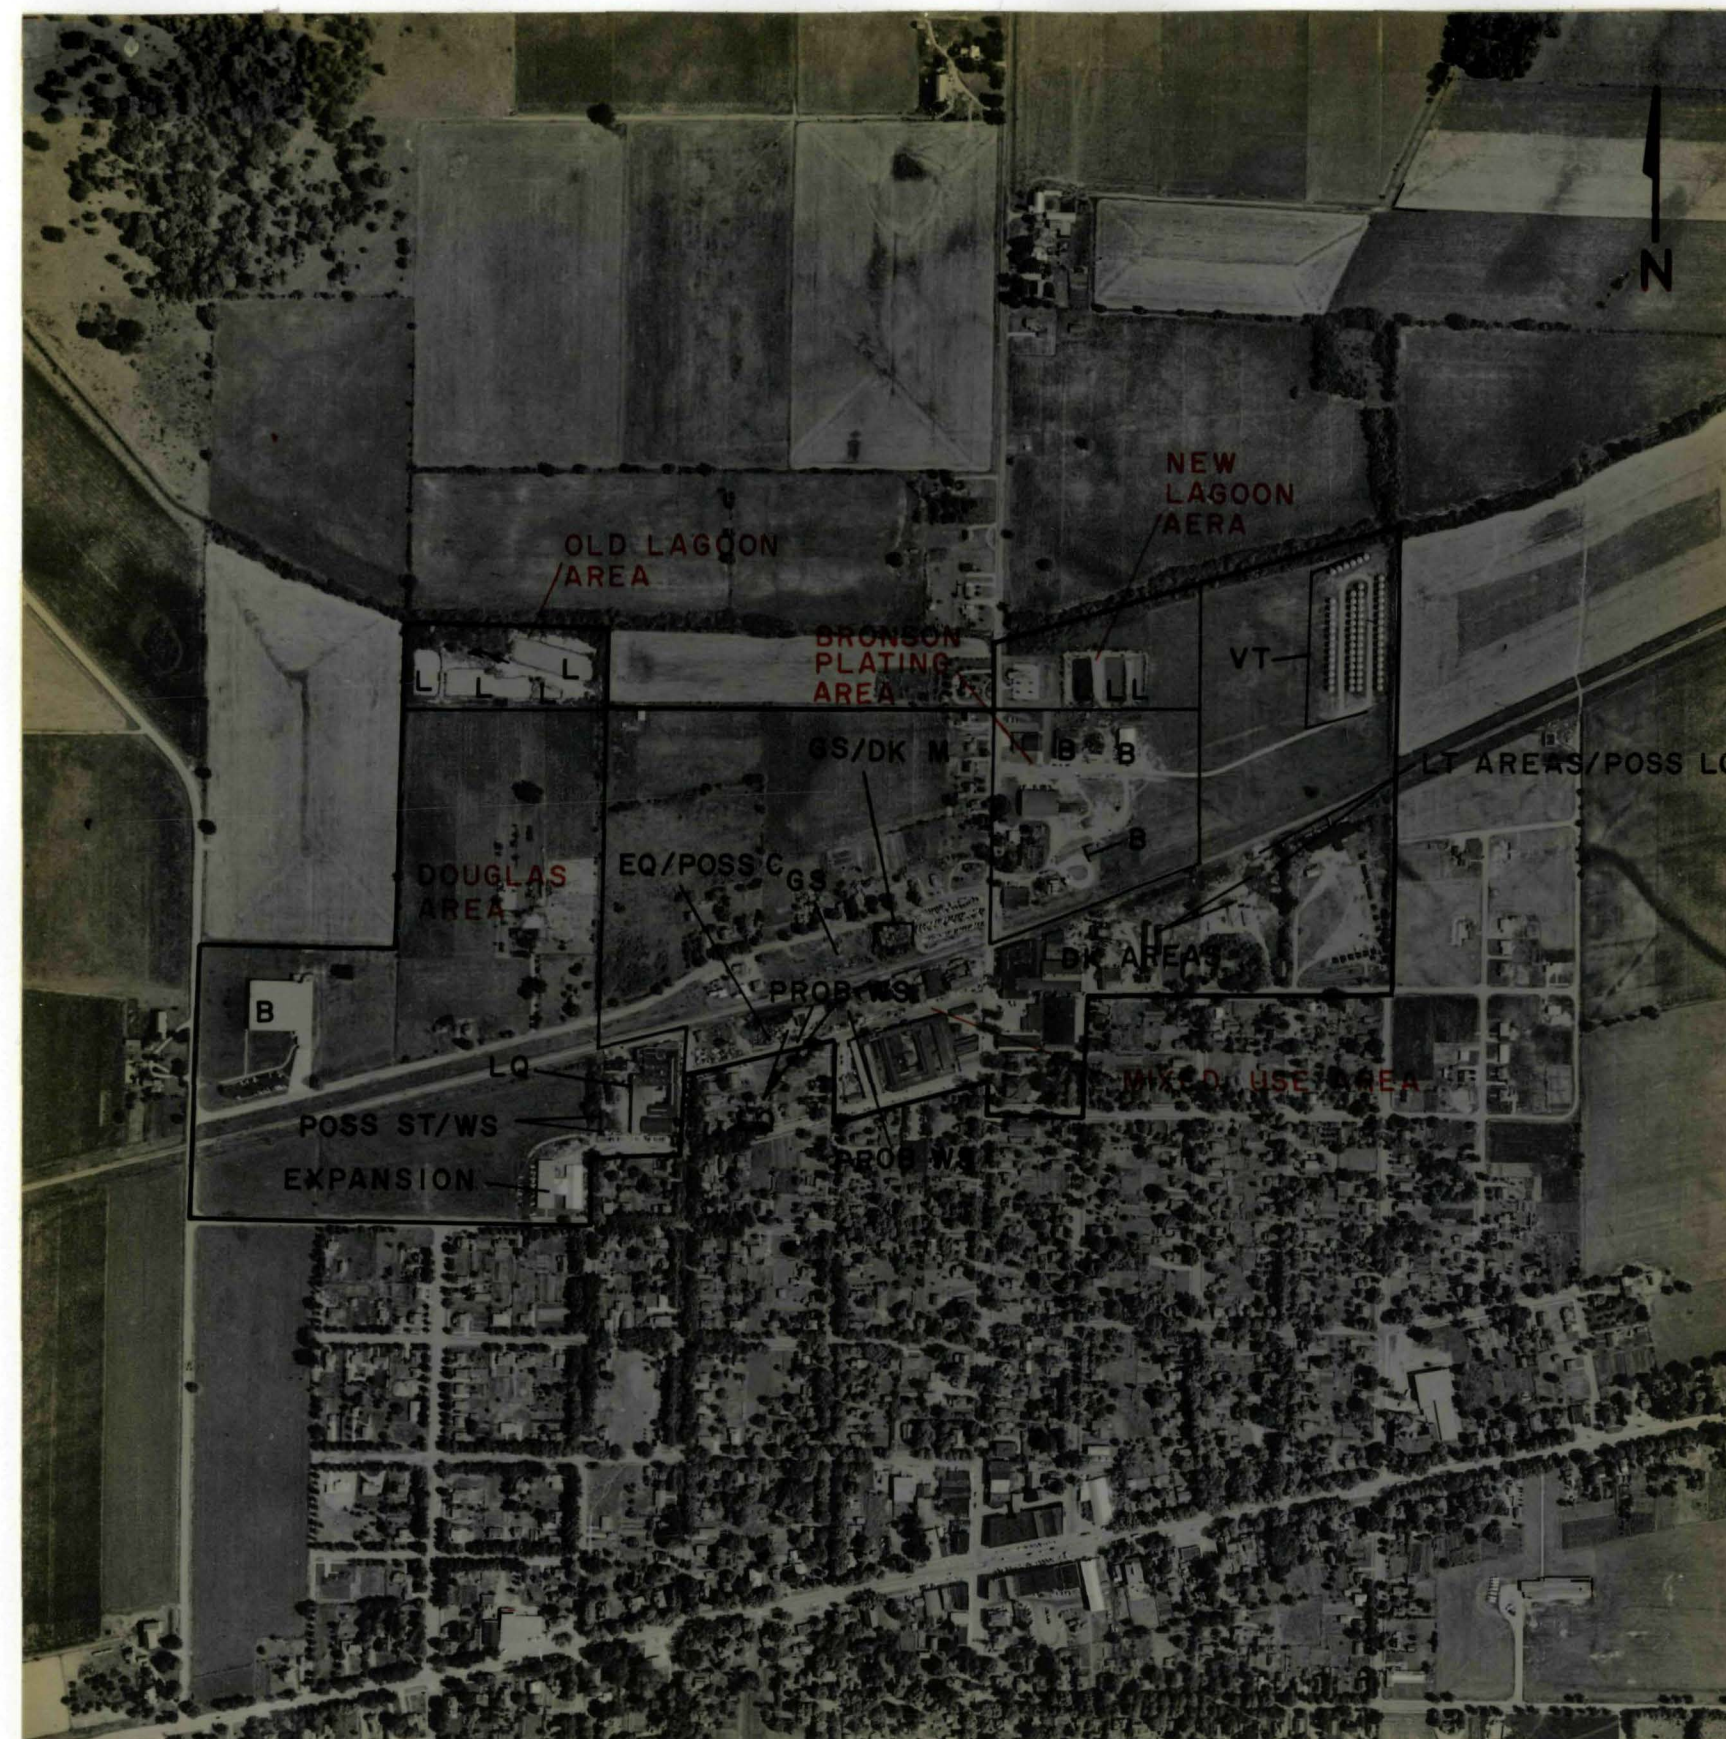
FIGURE 5
N. BRONSON IND.
AREA

A fourth lagoon is observed this year. This lagoon is smaller than the three seen in 1950. A drainage channel, located where possible piping material was seen in 1950, possibly drains into the tributary just north of the lagoons.

Possible stains/wet soil are seen in the same location as in 1950. Probable light-toned material seen here in 1950 is no longer evident.

Rectangular ground scars (GS) surrounded by dark-toned material are noted southwest of the Bronson Plating Area. This was an area of disturbed ground in 1950. Square ground scars are seen west of the rectangular ground scars.

Equipment (EQ) and possible containers (C) as well as liquid and probable wet soil are noted near the southern boundary of the Mixed Use Area. Liquid is also seen near the equipment/possible containers in the southwest corner of the Mixed Use Area.

The dark-toned areas farther east, near the eastern site boundary, may be areas of liquid or wet soil.

Light-toned areas, possibly liquid, are seen south of the railroad adjacent to the dark-toned areas. Light-toned material and liquid were seen in this location in 1950.

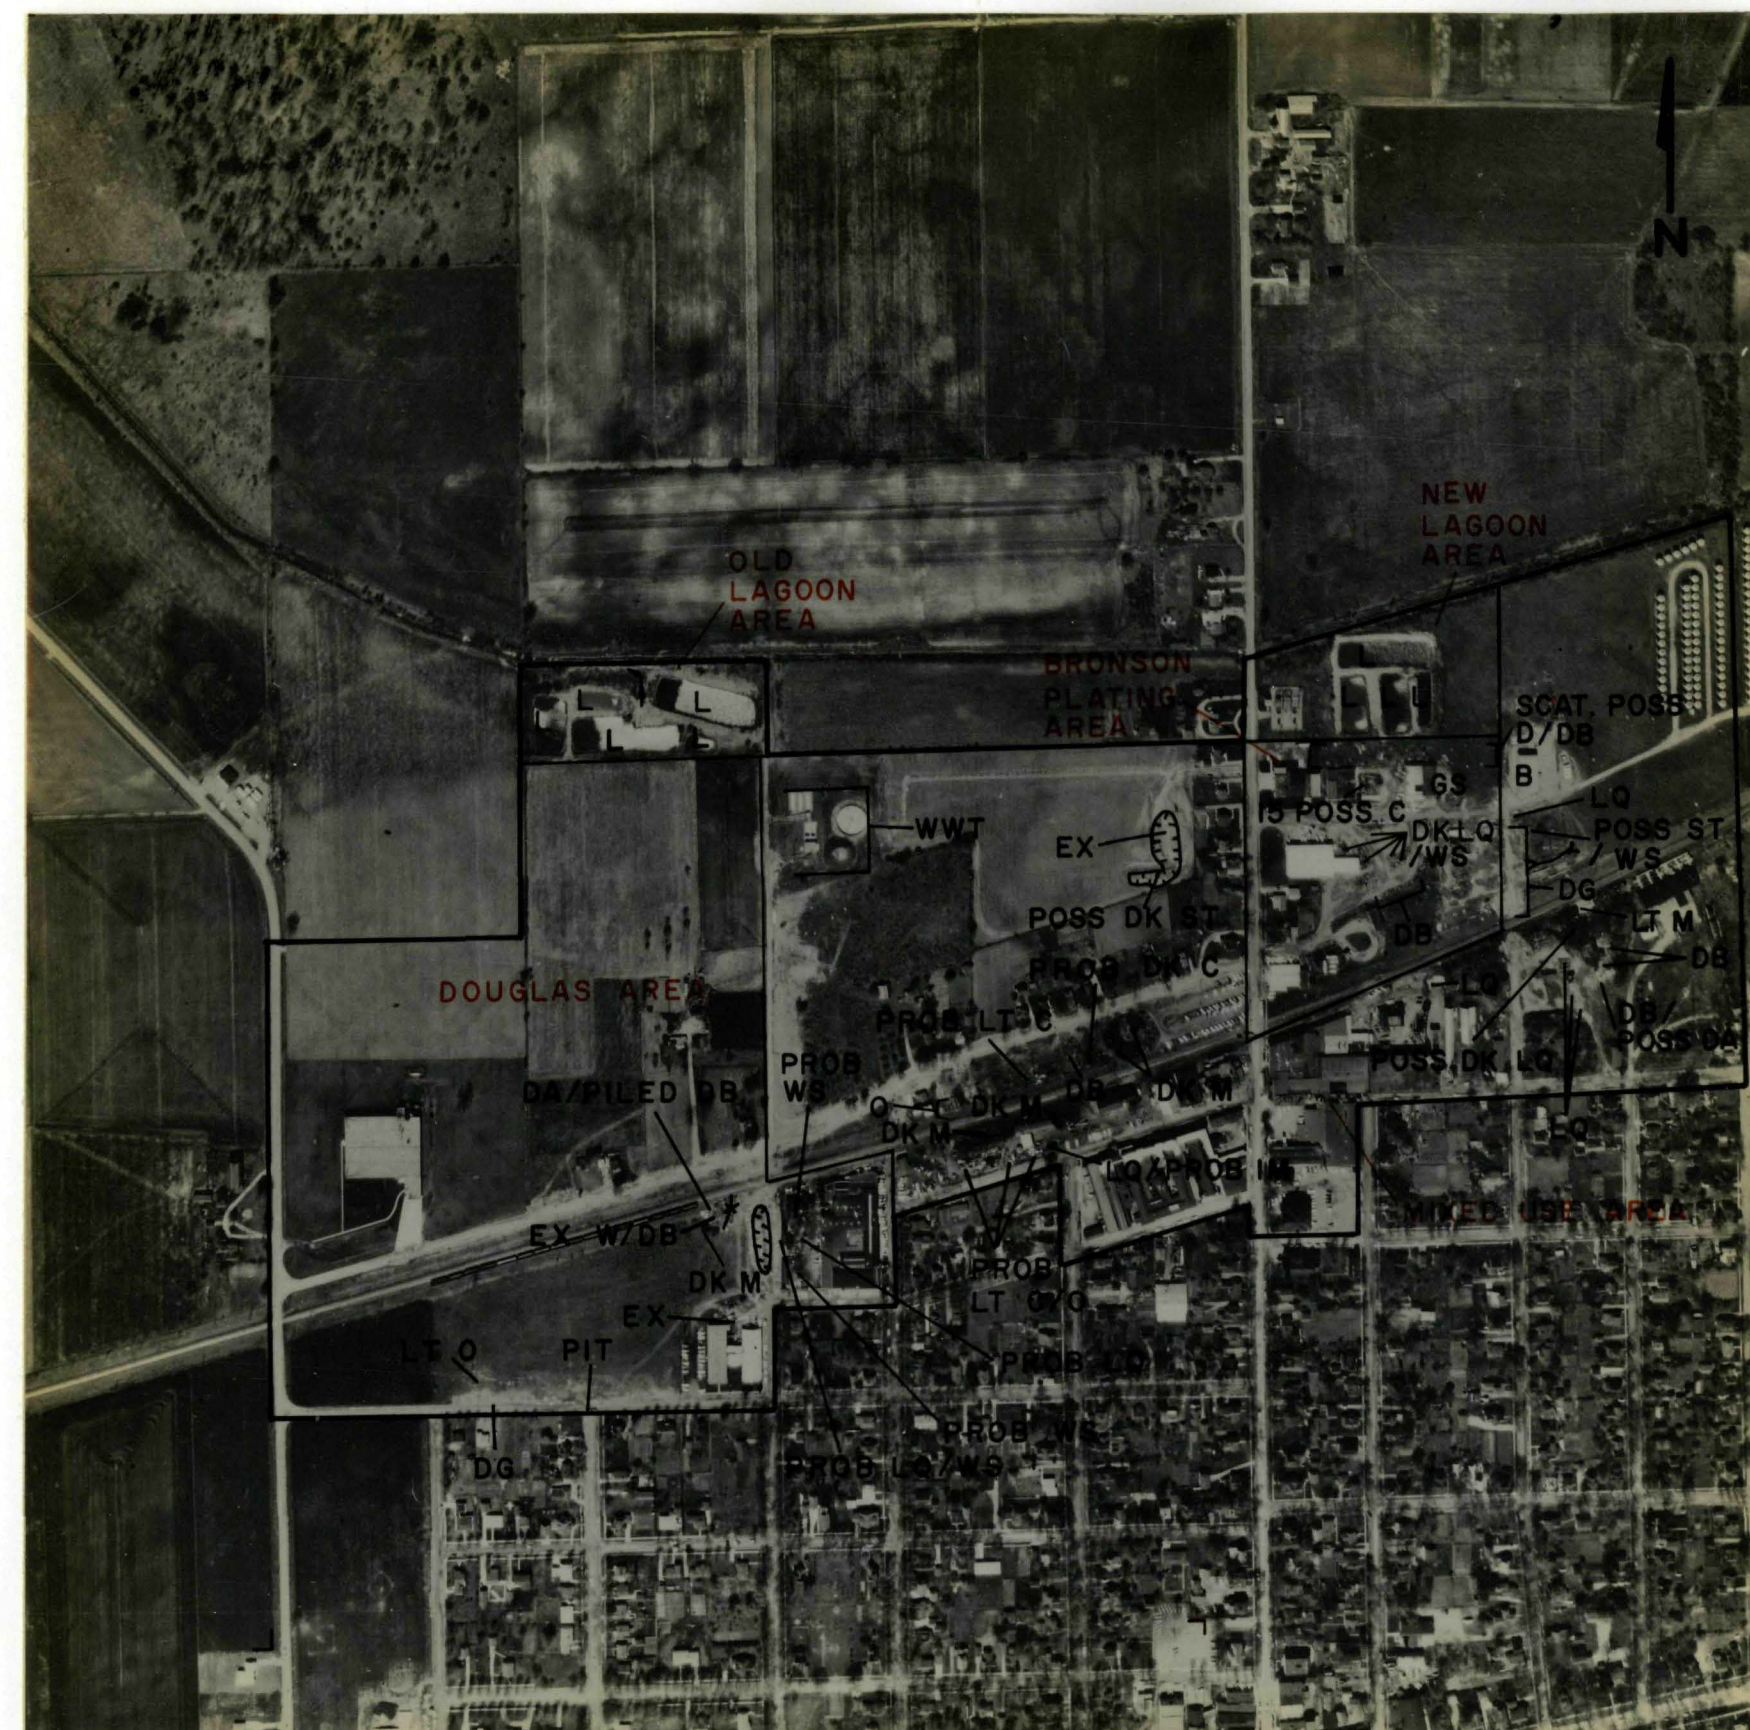
A probable drainage channel present since 1955 may drain liquid from this area into the tributary farther north. Lagoon construction has altered the location of this drainage channel.

Three excavations are noted in the Douglas Area. A disposal area (DA) consisting of piled debris (DB) and an excavation containing debris are noted in the southeastern portion of the Douglas Area. Dark-toned material, possibly waste material, is noted adjacent to this excavation, indicating probable burial. A fence contains the portion of the debris pile facing a second larger excavation farther southeast. A dark-toned stain (not annotated) is seen within this excavation. This area was vegetated in 1955. A third rectangular excavation is noted north of the southernmost building in this area.

Probable liquid is visible west of the building where possible stains/wet soil were noted in 1955.

An excavation with a possible dark-toned stain within it is seen west of the Bronson Plating Area.

Dark-toned material is visible west of a parking area where ground scars and dark-toned material were noted in 1955. A group of probable dark-toned containers with adjacent debris is seen farther west. Neatly placed probable light-toned containers and objects are observed farther west.

Dark-toned material similar to that west of the parking area is seen farther south. Probable light-toned containers and objects are scattered over a large area south of the dark-toned material. A small pool of liquid, probably an impoundment, is present east of the probable light-toned containers and objects. Liquid and probable wet soil were noted here in 1955.

A new building is visible in the Mixed Use Area east of the Bronson Plating Area. Liquid is seen south of the aforementioned building in a previously undisturbed area. A dark-toned area that indicates a possible stain or wet soil, and an area of disturbed ground are present near the eastern border of the Bronson Plating Area. A trench extends eastward from the disturbed ground.

Light-toned material is noted south of the railroad where a light-toned area and possible liquid were seen in 1955. Liquid and possible dark-toned liquid, disturbed ground, and piles of debris that appear to be a possible disposal area are observed southeast of the Bronson Plating Area.

Poor housekeeping is evident in this area. Scattered possible drums (D) mixed with debris are visible along the lagoons in the northern section of this area.

Piled debris, a ground scar, and possible debris (not annotated) are present south of the aforementioned drums. Five areas of dark-toned liquid and/or wet soil are seen in this area. Numerous ground scars (not annotated) are visible near the eastern boundary adjacent to the area of disturbed ground noted in the Mixed Use Area. A linear pile of debris is visible west of the aforementioned ground scars.

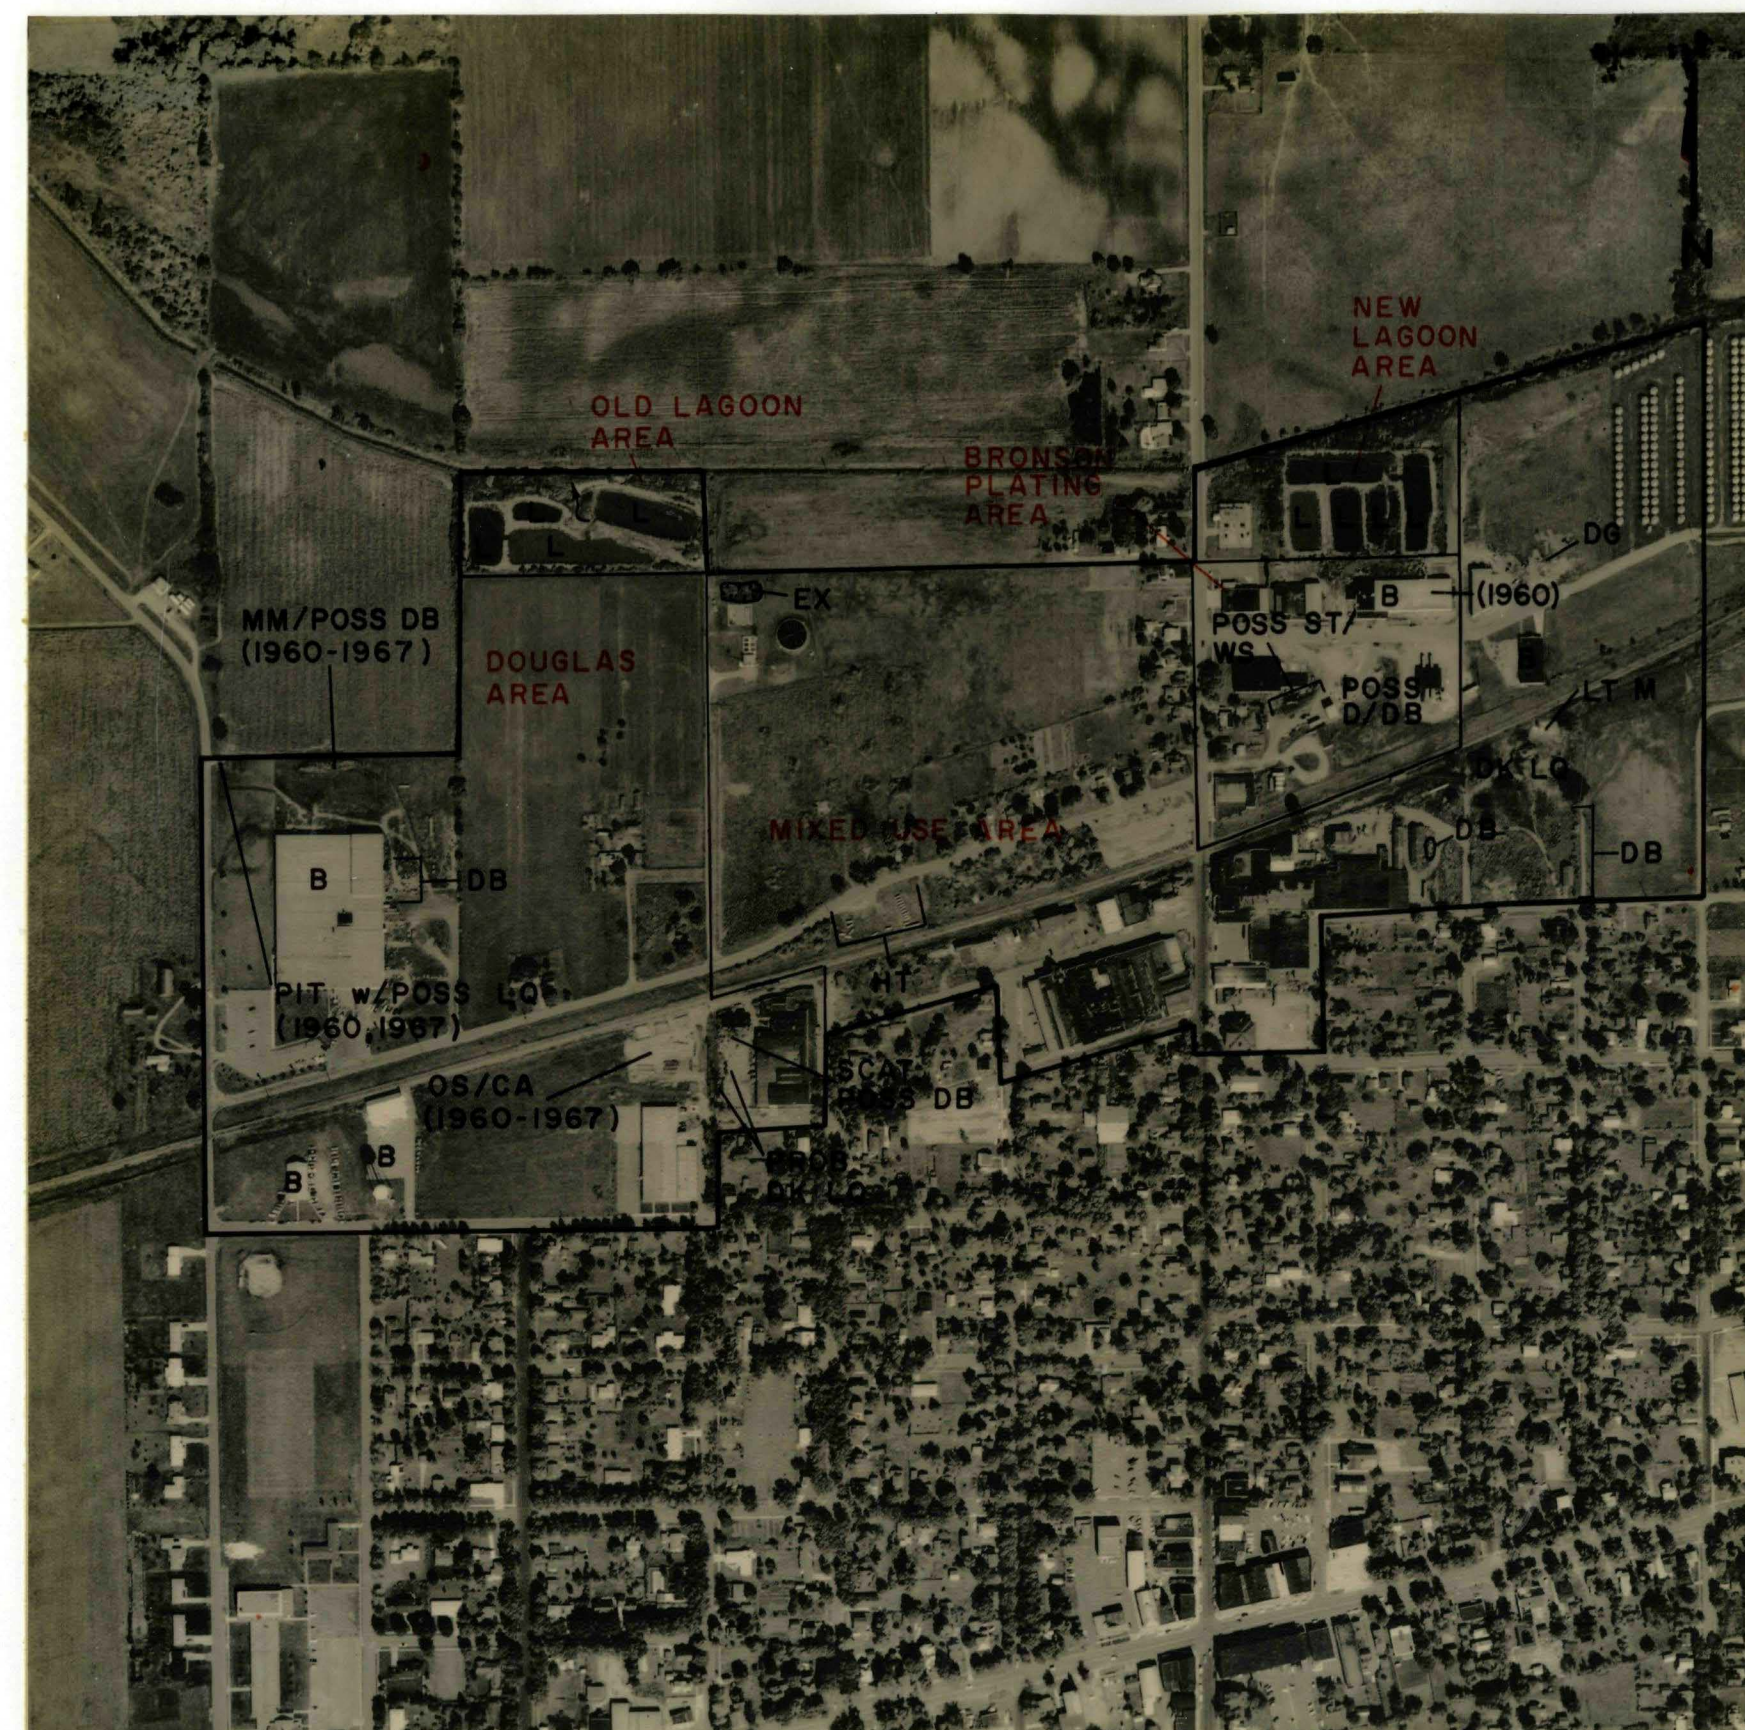
FIGURE 7
N. BRONSON IND. AREA
SEPTEMBER 23, 1967
APPROX. SCALE 1:6,000

A pit with possible liquid and mounded material (MM) interspersed with possible debris, first seen in 1960, are noted at the northwestern boundary. Expansion of the building south of these features occurred between 1958 and 1960. Scattered debris, also observed in 1960, is noted east of the building.

A cleared area (CA) with open storage (OS) of objects, first noted in 1960, is visible in the southeastern portion of the Douglas Area where a disposal area was seen in 1958. The larger excavation seen east of the aforementioned cleared areas in 1958 is filled by 1960.

Scattered possible debris is found east of the cleared area. Probable dark-toned liquid is noted where probable wet soil was seen in 1958.

Seventeen horizontal tanks (HT) are seen where possible drums were noted in 1958 and 1960 near the southwest corner of the Mixed Use Area. The probable containers and objects, debris, dark-toned material, and areas of liquid seen in the Mixed Use Area in 1958 and 1960 are no longer visible.

An area of light-toned material borders the railroad southeast of the Bronson Plating Area. Light-toned features have been noted here since 1950. Numerous areas of dark-toned liquid are also observed southeast of the Bronson Plating Area. Piled debris annotated with a polygon is noted southwest of the aforementioned dark-toned liquid.

An area of possible drums mixed with debris borders the New Lagoon Area. A second area of possible drums mixed with debris is present south of the aforementioned area. Possible drums and debris were also noted at this location in 1958 and 1960.

Staining or wet soil is noted where three such areas were seen in 1960.

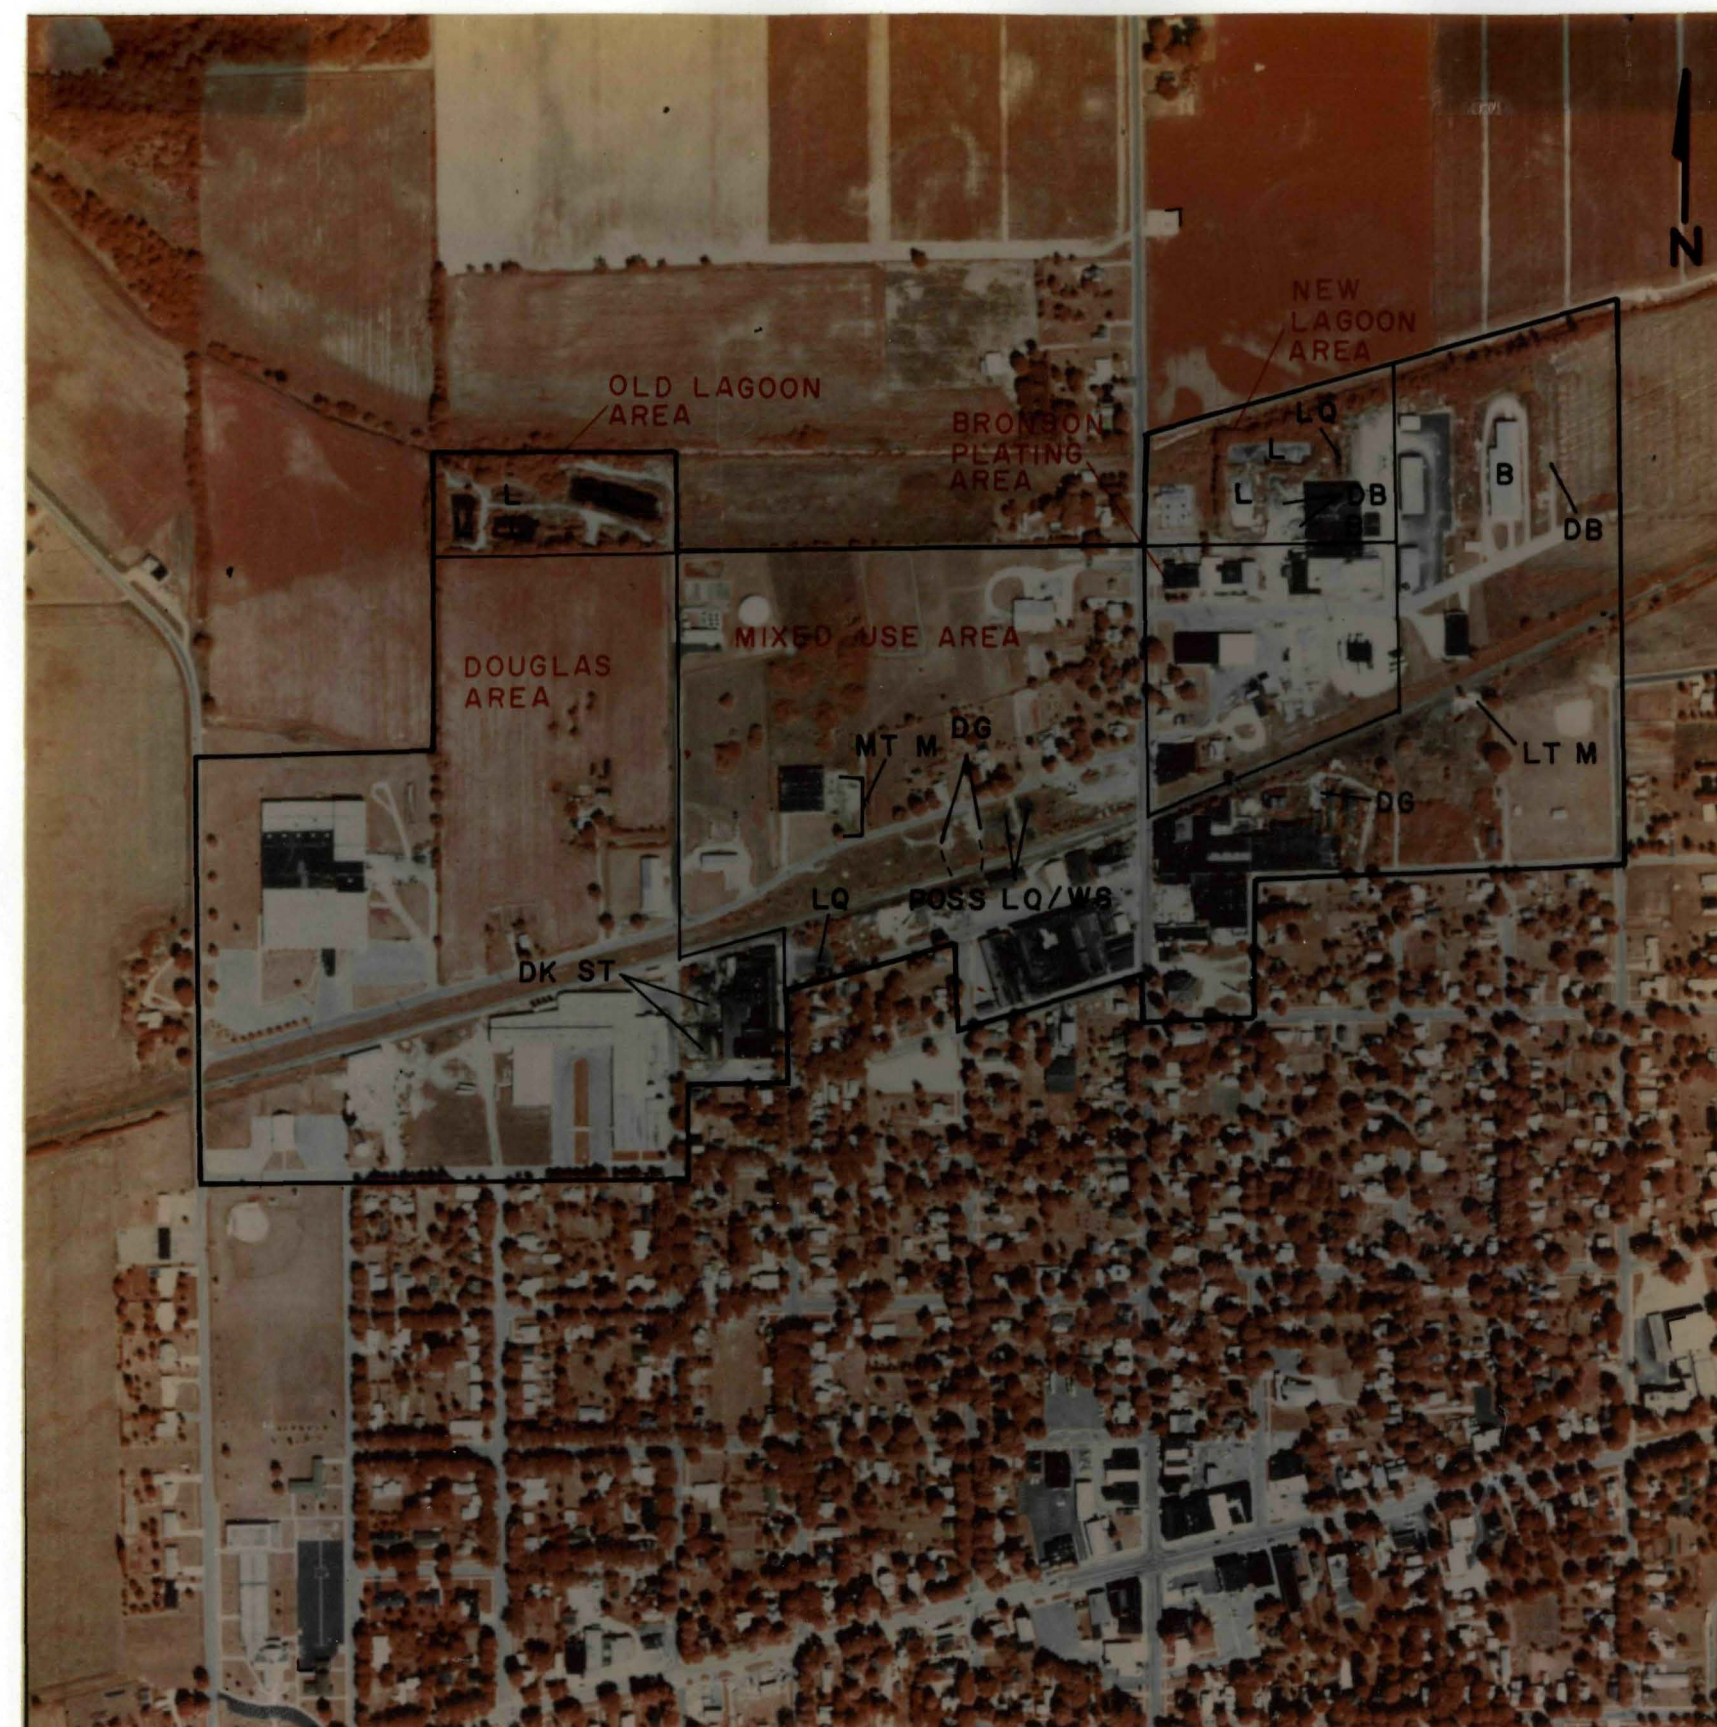
FIGURE 8
N. BRONSON IND. AREA
SEPTEMBER 4, 1978
APPROX. SCALE 1:6,400

Two lagoons are noted where five were present in 1967. A building, partially located in the Bronson Plating Area, has been constructed between 1967 and 1974. This building was constructed at the location of the three lagoons observed in 1967.

Dark-toned stains are noted in two locations west of a building in the southeast corner of the area.

Piled medium-toned (MT) material is seen east of a building in the center of this area. Two access roads extend from the roadway to two areas of disturbed ground. Liquid is noted at the southwest corner of the Mixed Use Area.

A pile of debris bordering a new building is seen in the northeast corner of the Mixed Use Area. This building is located northeast of where disturbed ground was noted in 1967.
